OPERATING EXPERIENCE WEEKLY SUMMARY

Office of Nuclear and Facility Safety

August 6 - August 12, 1999

Summary 99-32

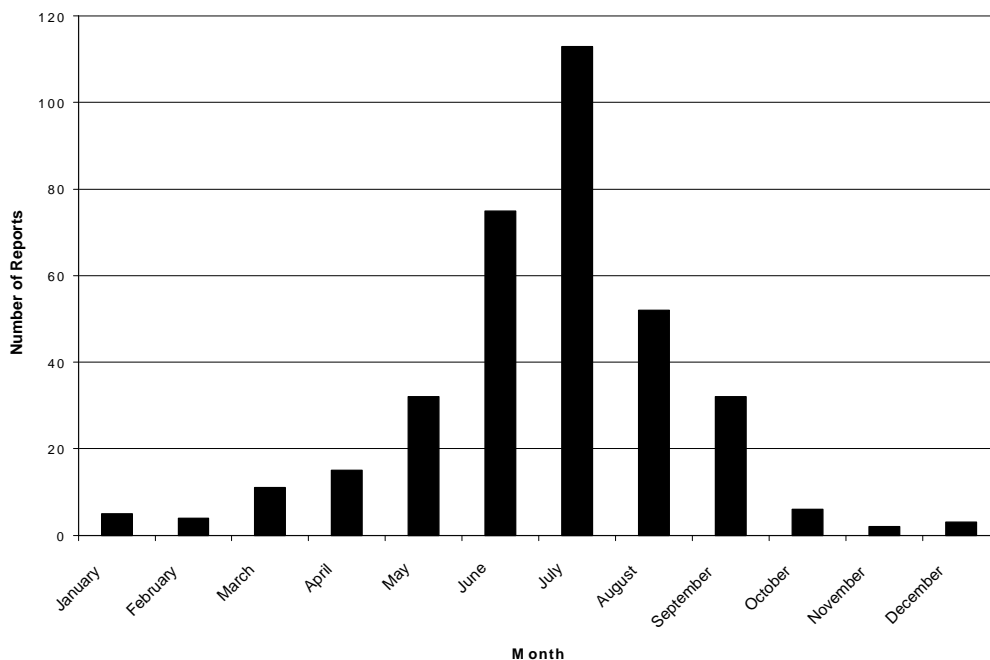
OEAF engineers reviewed heat stress information contained in the DOE Computerized Accident/Incident Reporting System (CAIRS) and found data on 350 instances with an injury code of "Heat Stroke/Other High Temp Effect" dating from 1981. Figure 2-1 shows the correlation between instances of heat stress and month of the year. The figure indicates that there is a significant peak period for such instances in July.

Figure 2-1. Heat Stress Events per Month
